USAAVLABS TECHNICAL REPORT 69-92

HOT CORROSION RESISTANCE OF MATERIALS FOR SMALL GAS TURBINE RECUPERATORS

December 1969

**THE GARRETT CORPORATION
AIRESEARCH MANUFACTURING COMPANY
LOS ANGELES, CALIFORNIA**

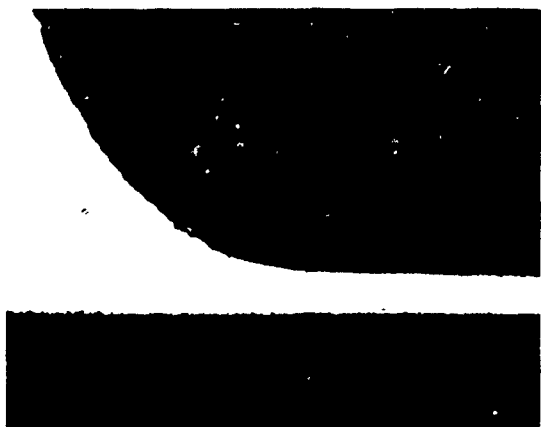
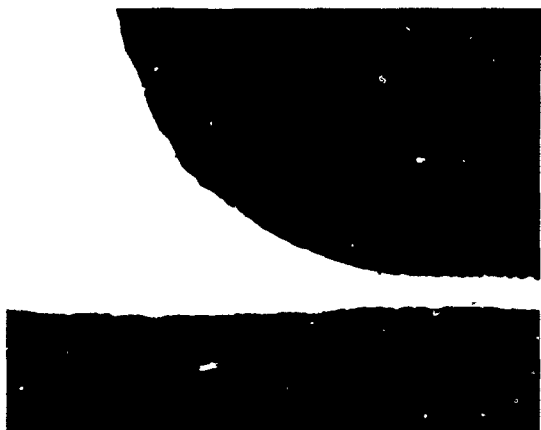
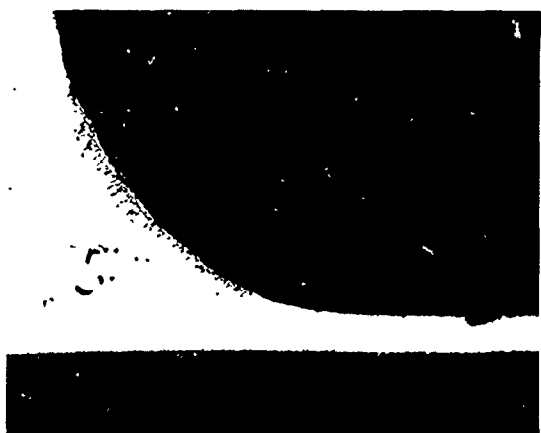
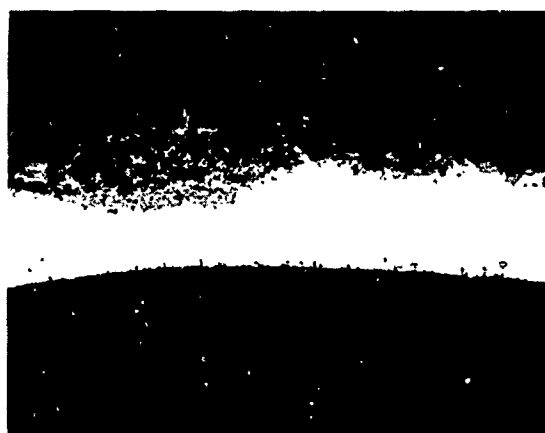
1500°F AND 20 KSI, FAILED AFTER 14.4 HOURS

1500°F AND 15.2 KSI, FAILED AFTER 25.7 HOURS

1500°F AND 10 KSI, FAILED AFTER 83.6 HOURS

Figure 87. Photomicrographs of Multimet N-155 Tubes
Brazed with Palniro I Brazing Alloy.

Photomicrographs of the areas examined are presented in Figures 87 through 124, and a commentary on the results is shown in Tables XXVI through XXXV.

Temperature (°F)	Stress (ksi)	Life (hr)	Visual Examination*				Metallographical Examination		Photomicrograph Figure No.
			Failure		Corrosion				
			Type	Location					
1500	20	14.4	P	-1	S	No corrosion	Grain boundary oxidation, completely penetrated	87	
1500	15.2	25.7	P	J	M	No corrosion	Internal oxidation, slight porosity	87	
1500	10	83.6	P	-1/4	M	Intergranular oxide layer	Wart. Metal 1 mil thick	87	
1500	4.5	1196.3	P	-3	M	No corrosion	Oxide layer 1/2 mil thick, internal oxidation	88	
1300	30	110.3	P	-1	S	No corrosion	Intergranular oxidation	88	
1300	26.7	87.9	P	J	S	No corrosion	Internal oxide layer	88	
1300	22.5	712.2	P	-1-1/2	M	Heavy oxide layer	Internal attack, oxide layer	89	
1300	22.5	106.7	P	J	M	Slight oxidation	Internal oxide layer at tube/braze interface	89	
1100	40	760.4	P	-1/2	M	No corrosion	Oxidized fissure	89	
1100	40	532.7	P	-4	S	No corrosion	Intergranular oxidation	-

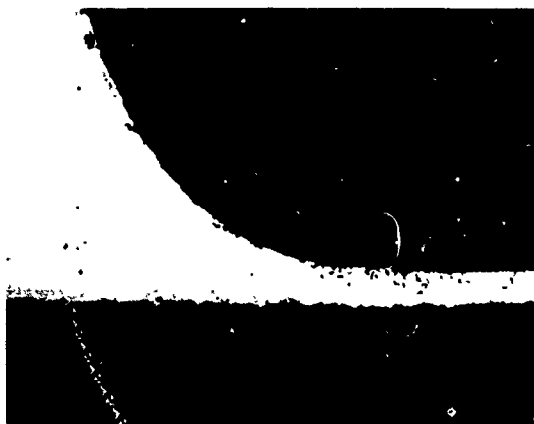
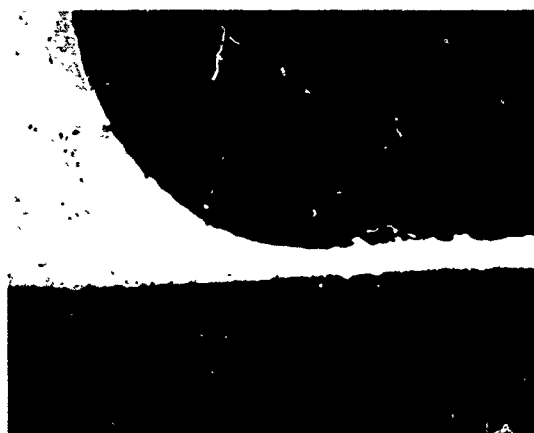
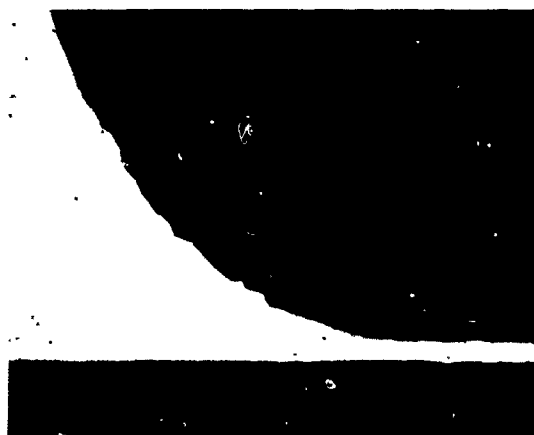
1500°F AND 4.5 KSI, FAILED AFTER 119.6 HOURS

1300°F AND 30 KSI, FAILED AFTER 110.3 HOURS

1300°F AND 26.7 KSI, FAILED AFTER 87.9 HOURS

Figure 88. Photomicrographs of Multimet N-155 Tubes
Braided With Palniro I Brazing Alloy.

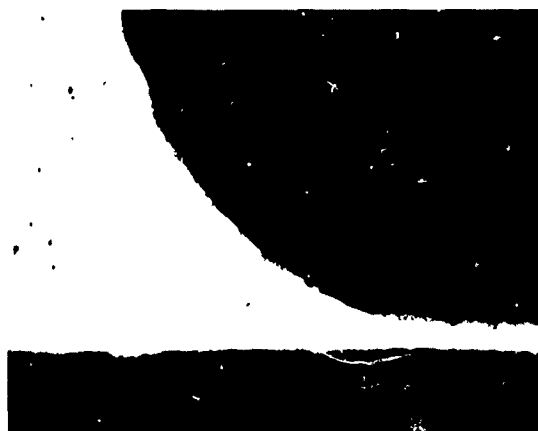
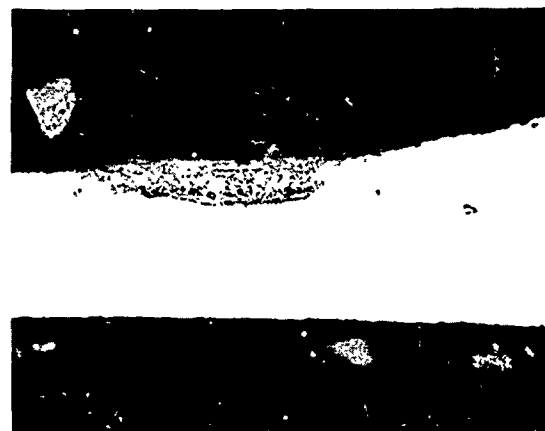
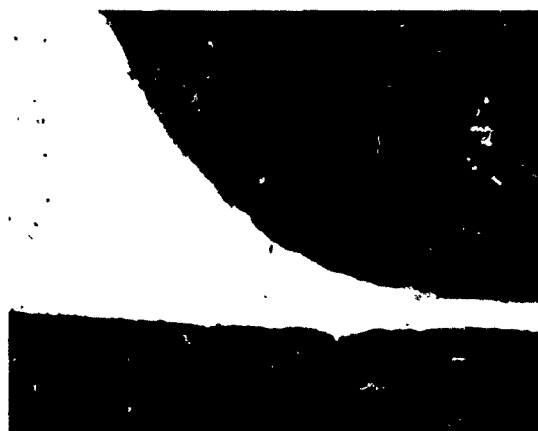
1300°F AND 22.5 KSI, FAILED AFTER 712.2 HOURS

1300°F AND 22.5 KSI, FAILED AFTER 106.7 HOURS

1100°F AND 40 KSI, FAILED AFTER 760.4 HOURS

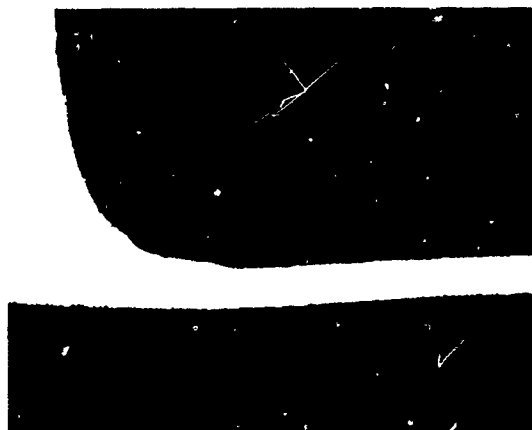
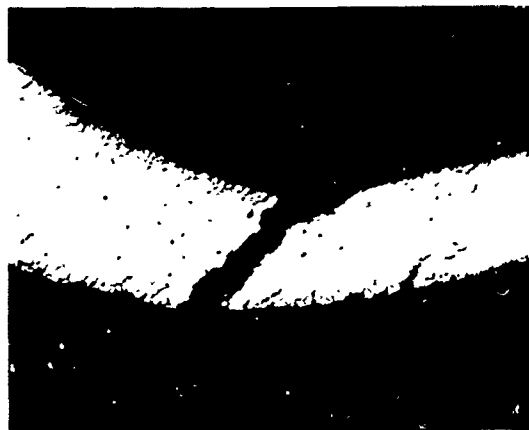
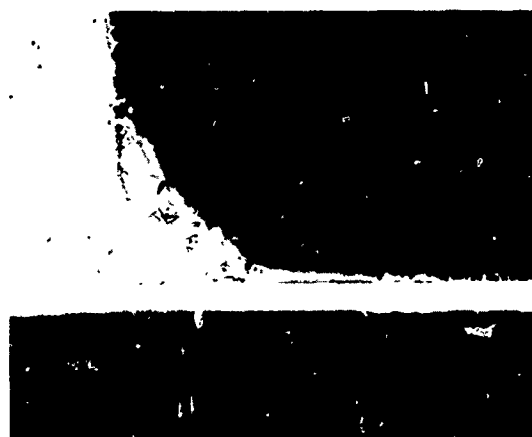
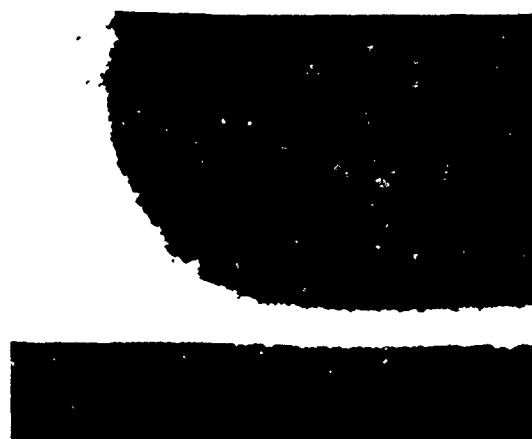
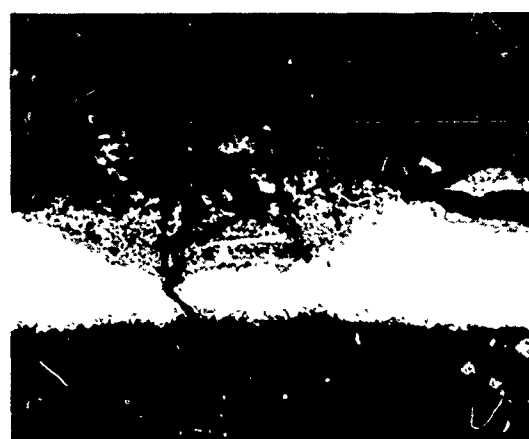
1500°F AND 20 KSI, FAILED AFTER 24.5 HOURS

1500°F AND 15.2 KSI, FAILED AFTER 7.8 HOURS

1500°F AND 10 KSI, FAILED AFTER 81.0 HOURS

Figure 90. Photomicrographs of Multimet N-155 Tubes
Brazed With Microbraz 200 Brazing Alloy.

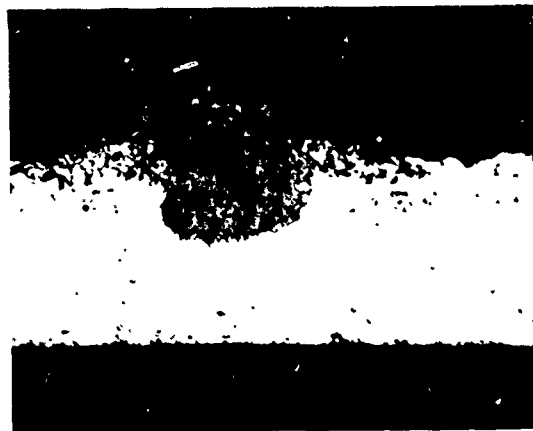
1500°F AND 4.5 KSI, FAILED AFTER 908.4 HOURS

1500°F AND 4.5 KSI, FAILED AFTER 967.5 HOURS

1300°F AND 26.7 KSI, FAILED AFTER 127.3 HOURS

Figure 91. Photomicrographs of Multimet N-155 Tubes
Brazed With Nicrobraz 200 Brazing Alloy.

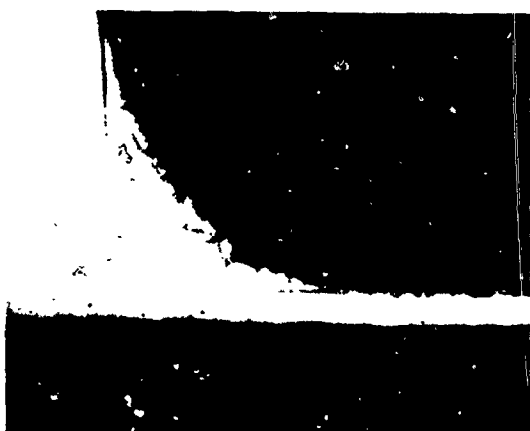
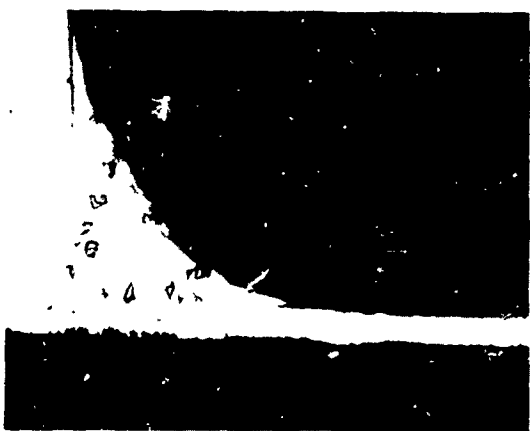
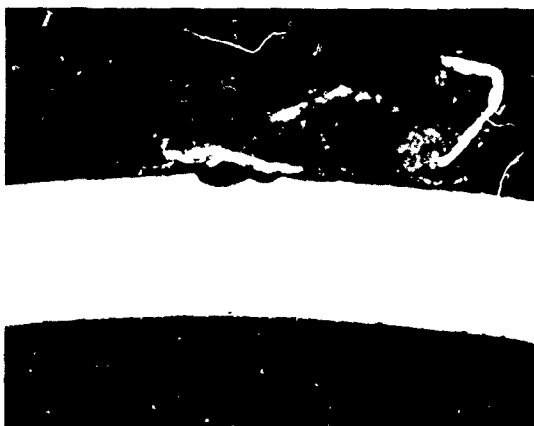
Figure 92. Photomicrographs of Multimet N-155 Tubes
Brazed With Nicrobraz 200 Brazing Alloy.

1300°F AND 26.7 KSI, FAILED AFTER 85.0 HOURS

1300°F AND 25 KSI, FAILED AFTER 398.6 HOURS

1300°F AND 22.5 KSI, FAILED AFTER 221.4 HOURS

TABLE XXVII. MULTIMET N-155 BRAZED WITH MICROBRAZ 200, FAILURE AND CORROSION EXAMINATION									
Temperature (°F)	Stress (ksi)	Life (hr)	Visual Examination*				Metallographical Examination		Photomicrograph Figure No.
			Failure		Corrosion	Braz Alloy Fillet	Point of Failure		
			Type	Location					
1500	20	24.5	P	-1	S	No corrosion	In. granular penetration, oxidized fissure	90	
1500	15.2	17.8	P	-1	S	No corrosion	Internal oxidation, porous	90	
1500	10	81	P	-1/2	M	Some surface oxidation	Intense local attack, wart	90	
1500	4.5	908.4	R	-5	M	Little surface corrosion	Internal oxidation, oxidized fissure	91	
1500	4.5	967.5	P	J	M	Heavy oxide layer	Intense local attack, wart	91	
1300	26.7	127.3	P	-10	S	No corrosion	Slight oxidation, crack	91	
1300	26.7	85.0	P	-1/2	S	No corrosion	Slight oxidation, crack	92	
1300	25	398.6	P	-5	S	No corrosion	Slight oxidation, intergranular and internal	92	
1300	22.5	221.4	P	-9	S	No corrosion	No evidence of failure	92

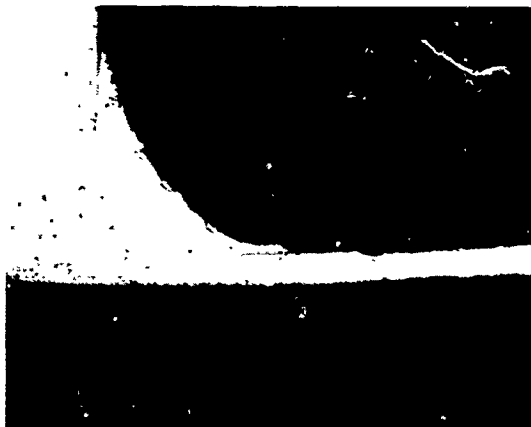
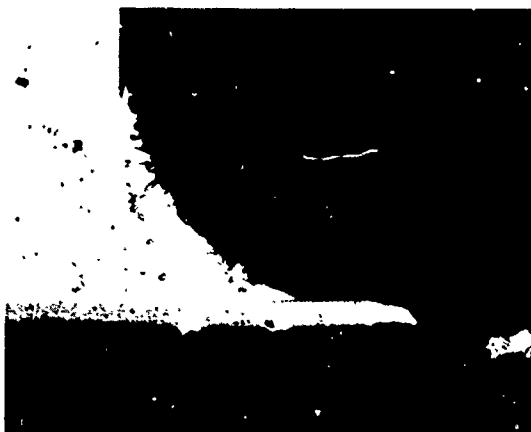
1300°F AND 22.5 KSI, FAILED AFTER 852.0 HOURS

1100°F AND 40 KSI, FAILED AFTER 1023.6 HOURS

1100°F AND 40 KSI, FAILED AFTER 485.2 HOURS

1300	22.5	852	P	-2	H	No corrosion	Intergranular oxidation, metal thickness = 0.001 in.	93	
1100	40	1023.6	P	-4	M	No corrosion	Internal oxidation	93	
1100	40	485.6	R	J	S	No corrosion	Intergranular penetration at tube/ braze interface	93	
*P = Pinhole leak; R = Tube rupture; J = Braze joint; + = Above J; - = Below J; S = Slight; M = Moderate; H = Heavy

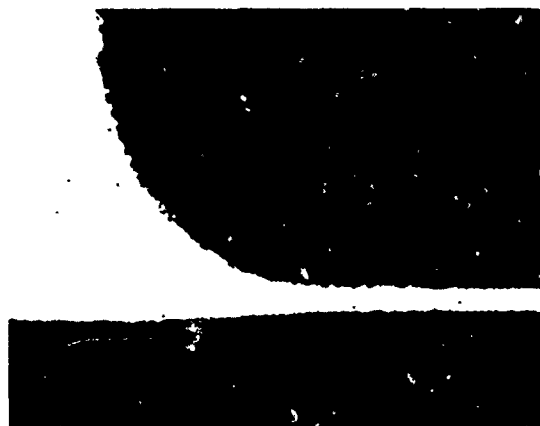
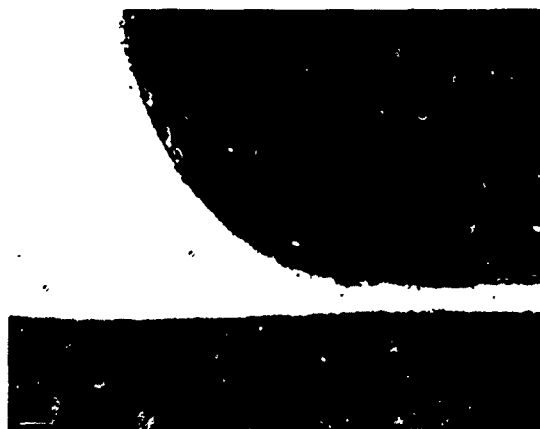
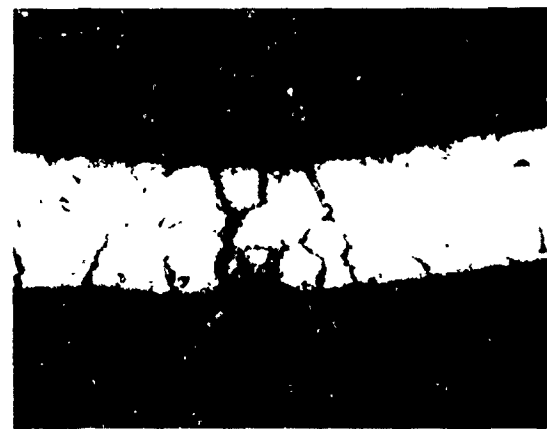
Figure 94. Photomicrographs of Hastelloy X Tubes
Brazed With Palnir I Brazing Alloy.

1500°F AND 13.9 KSI, FAILED AFTER 13.8 HOURS

1500°F AND 9.0 KSI, FAILED AFTER 114.4 HOURS

1500°F AND 9.0 KSI, FAILED AFTER 135.9 HOURS

TABLE XXVIII. HASTELLOY X BRAZED WITH PALNIRO 1, FAILURE AND CORROSION EXAMINATION									
Temperature (°F)	Stress (ksi)	Life (hr)	Visual Examination*			Metallographical Examination		Photomicrograph Figure No.	
			Failure		Corrosion	Braze Alloy Fillet	Point of Failure		
			Type	Location					
1500	13.9	13.8	P	-2 in.	S	Very light intergranular corrosion	Extensive grain boundary oxidation	94	
1500	7.0	114.4	P	J	S	Slight intergranular corrosion	Grain boundary oxidation, some internal oxidation	94	
1500	9.0	135.9	P	+1/4	S	Slight intergranular corrosion	Extensive grain boundary oxidation	94	
1500	6.5	35.4	P	J	S	Moderate internal oxidation layer	Internal oxidation at interface		
1500	6.5	277	R	-1/2	S	Slight intergranular corrosion	Internal oxidation, porous	95	
1500	6.5	341.3	R	J	H	Heavy internal oxidation layer	Internal oxidation, porous	95	
1500	4.5	325.8	P	J	H	Slight intergranular corrosion	Internal oxidation, porous	95

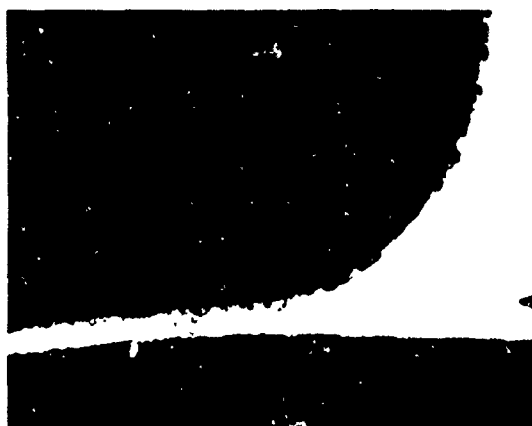
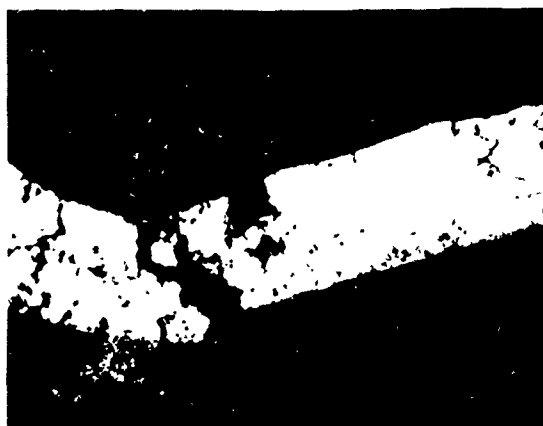
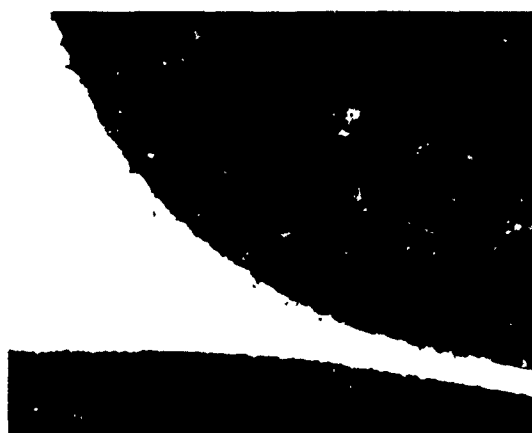
Figure 95. Photomicrographs of Hastelloy X Tubes
Brazed With Palniro I Brazing Alloy.

1500°F AND 6.5 KSI, FAILED AFTER 277.0 HOURS

1500°F AND 6.5 KSI, FAILED AFTER 341.3 HOURS

1500°F AND 4.5 KSI, FAILED AFTER 325.8 HOURS

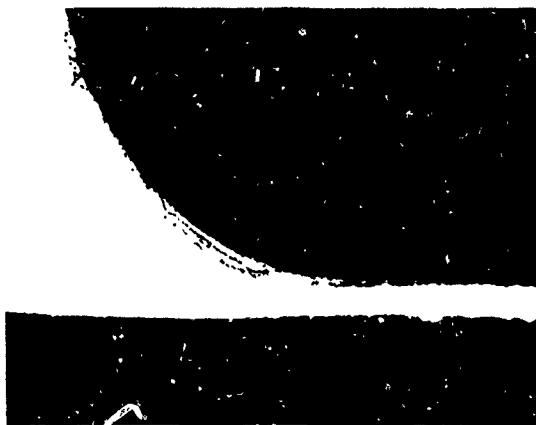
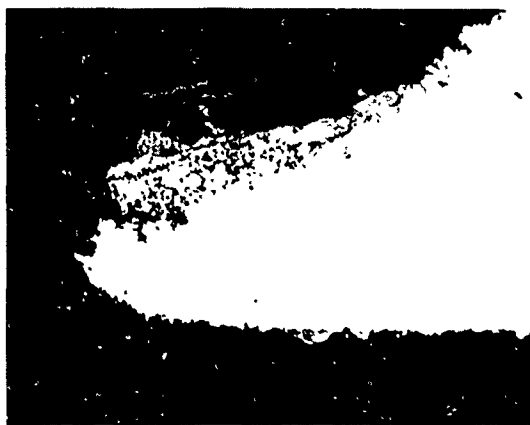
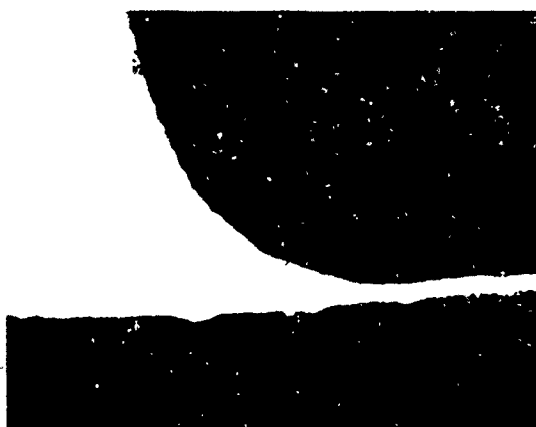
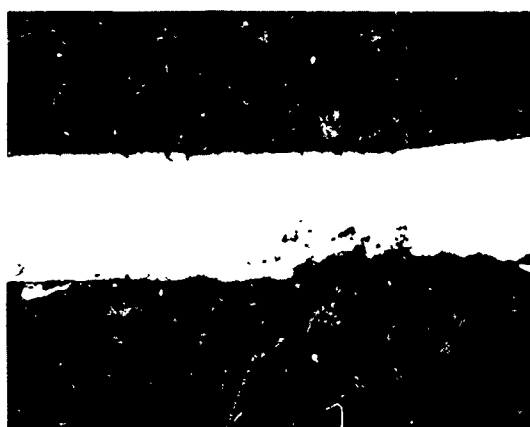
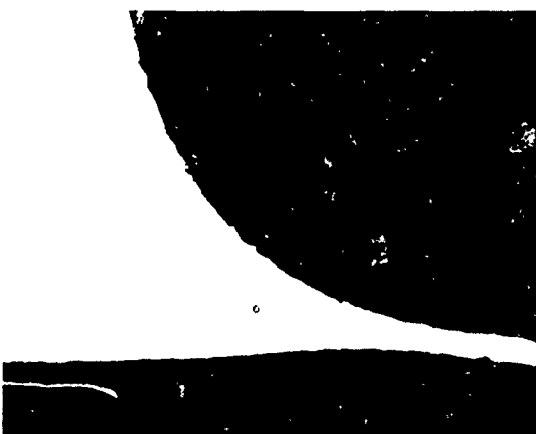
Figure 96. Photomicrographs of Hastelloy X Tubes
Brazed With Palniro I Brazing Alloy.

1300°F AND 20.8 KSI, FAILED AFTER 175.2 HOURS

1300°F AND 19.1 KSI, FAILED AFTER 187.2 HOURS

1300°F AND 19.1 KSI, FAILED AFTER 385.6 HOURS

1300	20.8	175.2	R	J	S	Some internal oxidation	Internal oxidation at interface	96	
1300	19.1	187.2	P	J	H	Very slight internal corrosion	Internal oxidation, porous	96	
1300	19.1	385.6	P	-2 in.	H	Very slight internal corrosion	Grain boundary oxidized	96	
1300	16.0	424.7	P	+1/4	H	No corrosion	Very little oxidation	97	
1300	16.0	951.4	P	+6	H	No corrosion	Extensive grain boundary oxidation	97	
1100	34.7	1121	P	+2	S	No corrosion	Slight intergranular oxidation	97

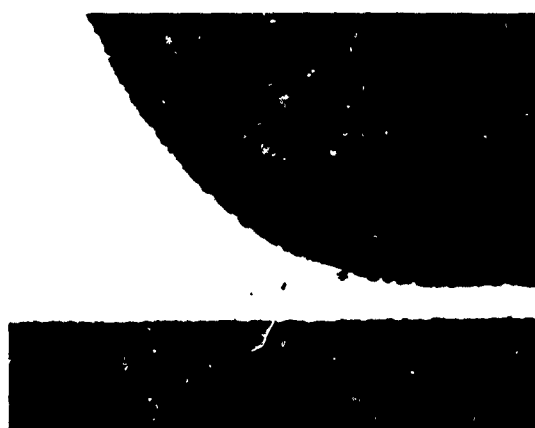
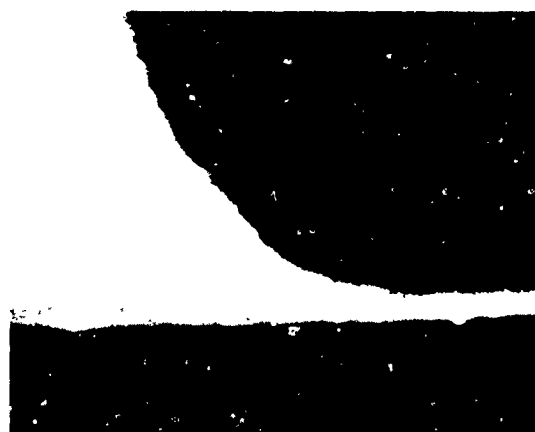
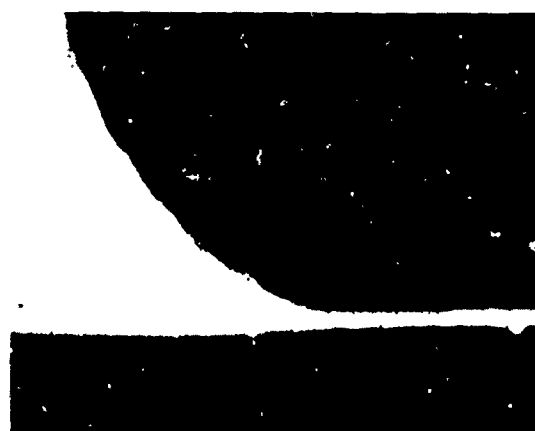
1300°F AND 16 KSI, FAILED AFTER 424.7 HOURS

1300°F AND 16 KSI, FAILED AFTER 951.4 HOURS

1100°F AND 34.7 KSI, FAILED AFTER 1121.0 HOURS

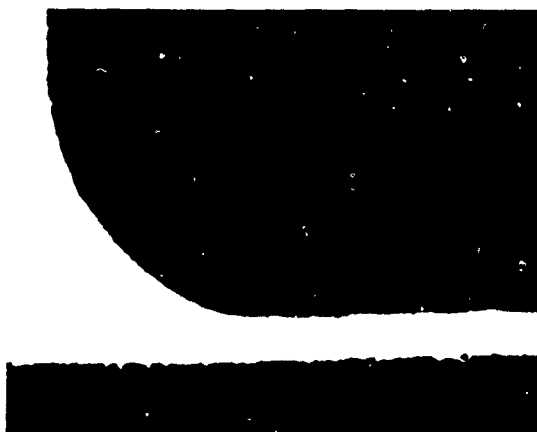
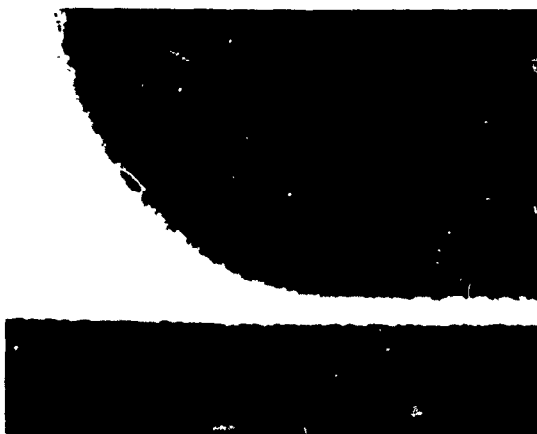
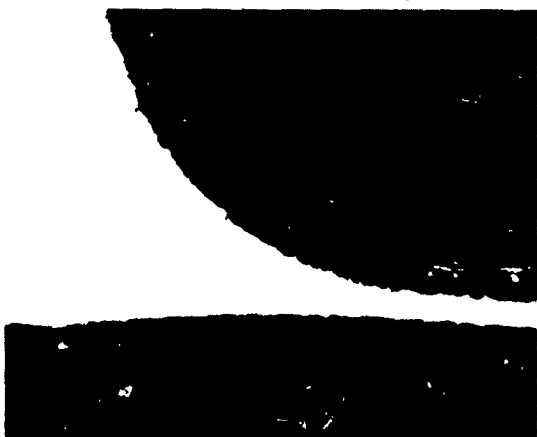
1500°F AND 13.9 KSI, FAILED AFTER 28.1 HOURS

1500°F AND 9 KSI, FAILED AFTER 171.4 HOURS

Temperature (°F)	Stress (ksi)	Life (hr)	Visual Examination*			Metallographical Examination		Photomicrograph Figure No.
			Failure		Corrosion	Braze Alloy Fillet	Point of Failure	
			Type	Location				
1500	13.9	28.1	P	-1	S	No corrosion	Intergranular penetration 1/3 way through	98
1500	9.0	171.4	P	-1	M	No corrosion	Intergranular penetration all way through	98
1500	6.5	156.6	P	J	S	No corrosion	Intergranular oxidation, some porosity	98
1500	6.5	141.8	P	-1	M	Slight oxidation	Intergranular penetration all way through	99
1500	4.5	418.9	P	J	M	Slight intergranular oxidation	Some intergranular oxidation	99
1300	25	122.2	P	-1-1/2	S	No corrosion	Intergranular oxidation	99
1300	20.0	204.4	P	-1	S	No corrosion	Intergranular penetration 3/4 way through	100
1300	20.0	344.4	P	-2	M	No corrosion	Intergranular penetration 1/2 way through	100
1300	20.0	991.0	P	-1	M	Slight intergranular attack	Intergranular penetration all way through	100

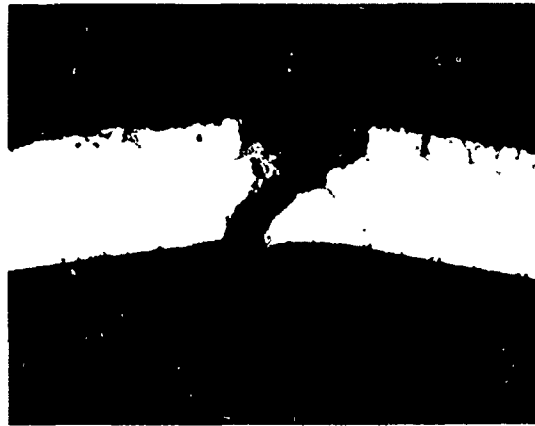
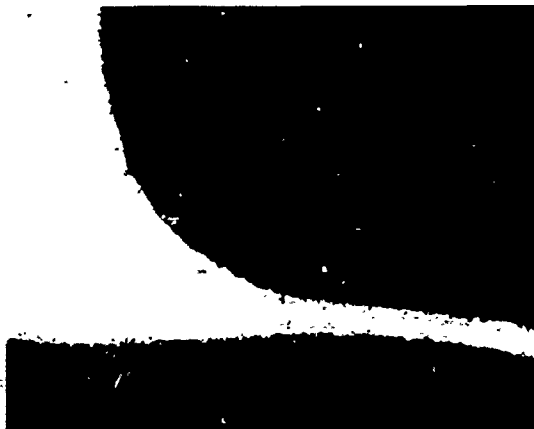
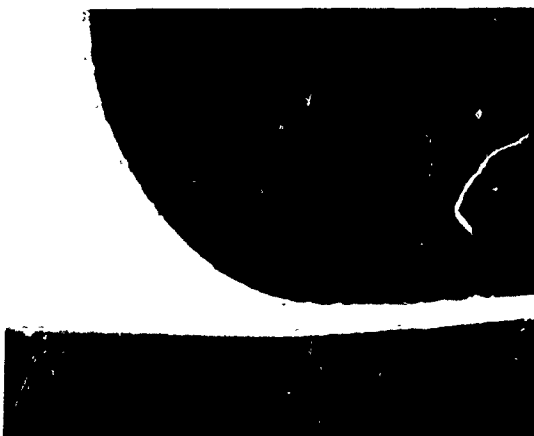
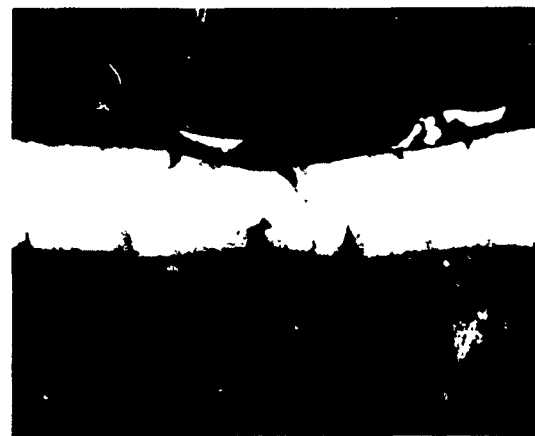
Figure 99. Photomicrographs of Hastelloy X Tubes Brazed With J-8100 Brazing Alloy.

1500°F AND 6.5 KSI, FAILED AFTER 141.8 HOURS

1500°F AND 4.5 KSI, FAILED AFTER 418.9 HOURS

1300°F AND 25 KSI, FAILED AFTER 122.2 HOURS

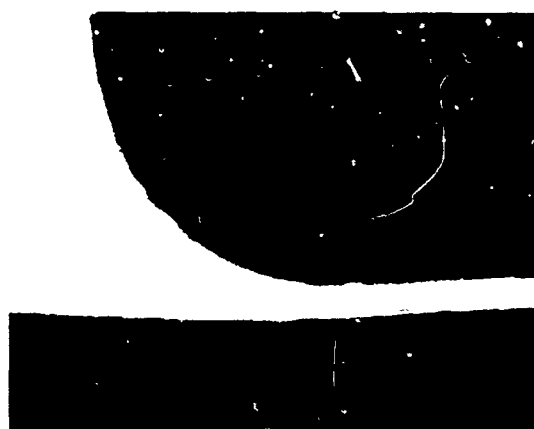
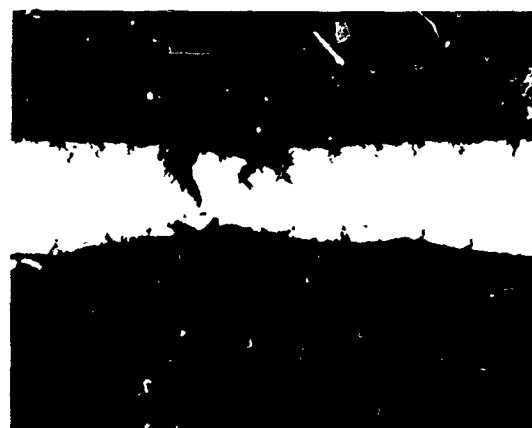
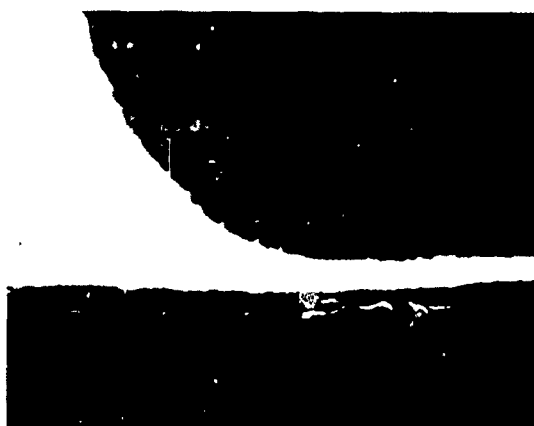
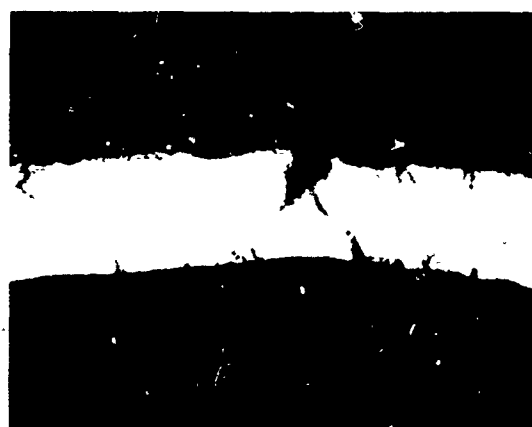
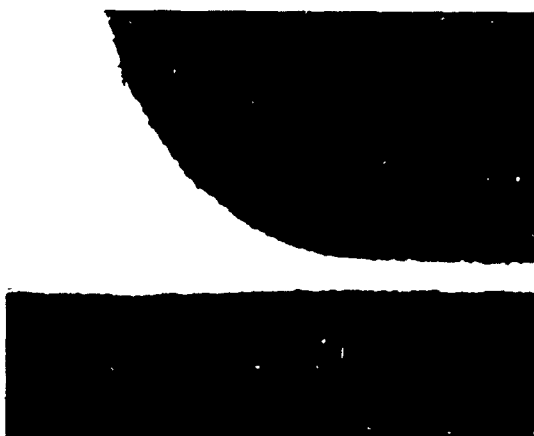
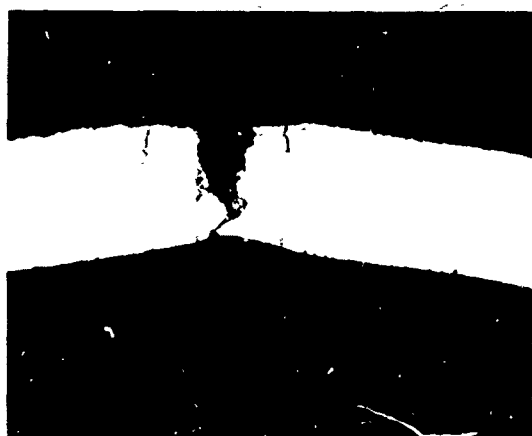
Figure 100. Photomicrographs of Hastelloy X Tubes
Brazed With J-8100 Brazing Alloy.

1300°F AND 20.8 KSI, FAILED AFTER 204.4 HOURS

1300°F AND 20 KSI, FAILED AFTER 344.4 HOURS

1300°F AND 20 KSI, FAILED AFTER 991.0 HOURS

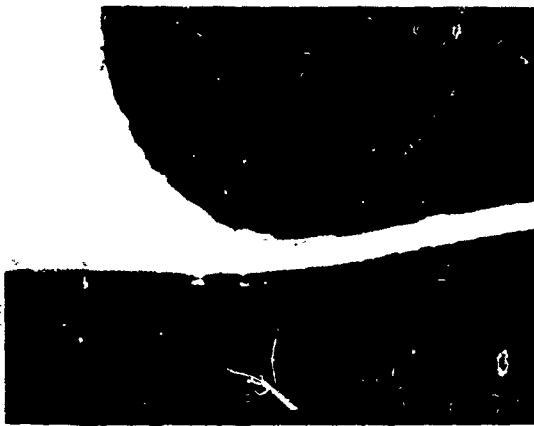
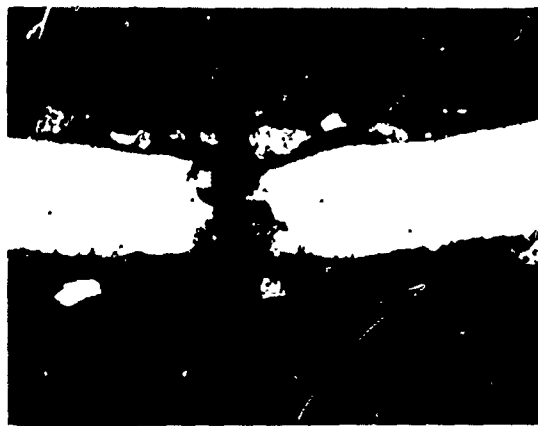
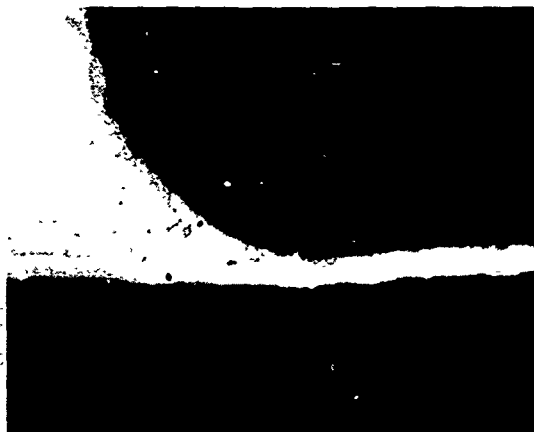
1100°F AND 34.7 KSI. FAILED AFTER 364.2 HOURS

1100°F AND 34.7 KSI. AFTER 1507.5 HOURS WITHOUT FAILURE

1100	34.7	364.2	P	-1	S	No corrosion	Intergranular attack, little oxidation	101
1100	34.7	1507.5	No failure		S	No corrosion	Slight surface layer of corrosion products	101

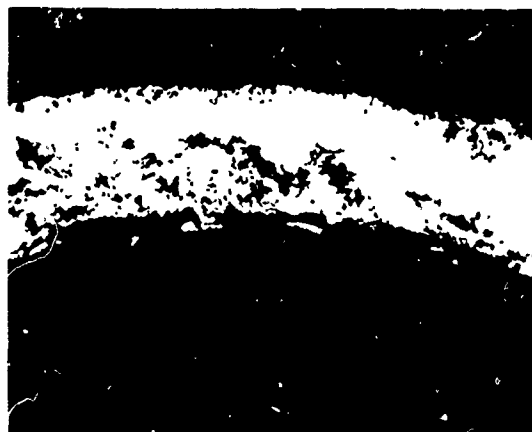
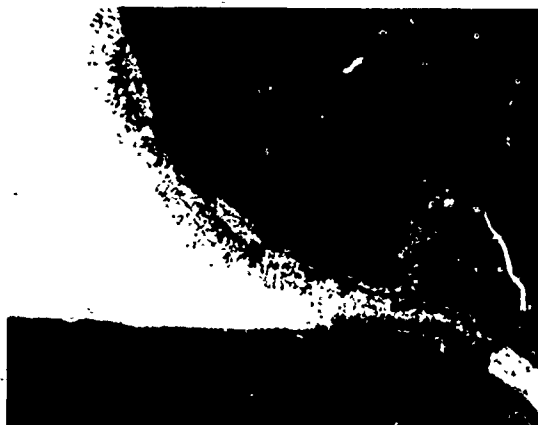
Figure 102. Photomicrographs of Incoloy 800 Tubes
Brazed With Palnro 7 Brazing Alloy.

1500°F AND 8.3 KSI, FAILED AFTER 16.4 HOURS

1500°F AND 2.8 KSI, FAILED AFTER 361.4 HOURS

1500°F AND 1.21 KSI, FAILED AFTER 644.3 HOURS

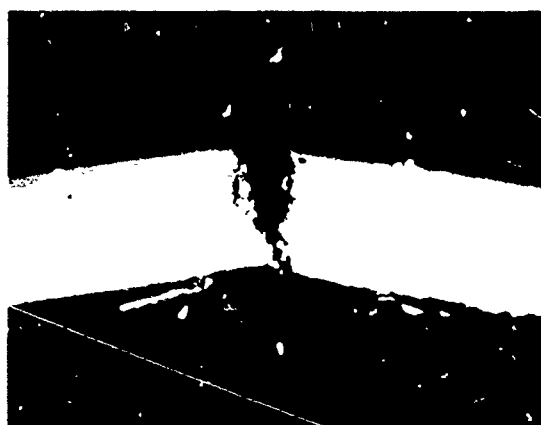
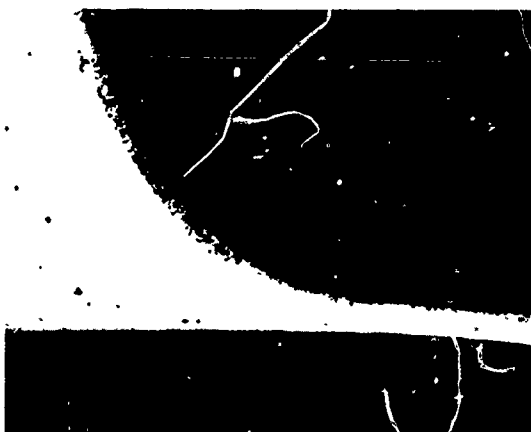
Figure 103. Photomicrographs of Incoloy 800 Tubes Brazed With Palniro 7 Brazing Alloy.

1500°F AND 1.2 KSI, AFTER 1501.7 HOURS WITHOUT FAILURE

1300°F AND 15.3 KSI, FAILED AFTER 35.4 HOURS

1300°F AND 9.5 KSI, FAILED AFTER 201.7 HOURS

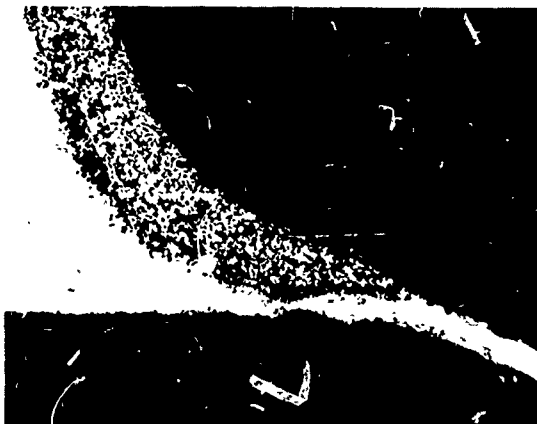
Figure 104. Photomicrographs of Incoloy 800 Tubes
Brazed With Palniro 7 Brazing Alloy.

1300°F AND 6.1 KSI, FAILED AFTER 1105.0 HOURS

1300°F AND 6.1 KSI, FAILED AFTER 490.6

1100°F AND 30 KSI, FAILED AFTER 68.2 HOURS

TABLE XXX. INCOLOY 800 BRAZED WITH PALNIRO 7, FAILURE AND CORROSION EXAMINATION									
Temperature (°F)	Stress (ksi)	Life (hr)	Visual Examination*			Metallographical Examination			Photomicrograph Figure No.
			Failure		Corrosion	Braze Alloy Fillet	Point of Failure		
			Type	Location					
1500	8.3	16.4	P	J	S	Slight intergranular corrosion	Oxidized through, porous	102	
1500	2.8	361	P	+1/4	H	Heavy corrosion	Oxidized through at fillet/tube interface	102	
1500	1.2	644.3	R	J	H	Extensive oxidation	Oxidized th-ough, porous	102	
1500	1.2	1501.7	No failure		H	Slight intergranular corrosion	Oxidized through, porous	103	
1300	15.3	35.4	P	+1-1/4	S	Slight intergranular corrosion	No general penetration, oxidized fissure	103	
1300	9.5	201.7	P	J	H	Slight intergranular corrosion	Corrosion layer 1-1/2 mil intergranular penetration	103	
1300	6.1	1103	P	J	H	Heavy corrosion	Extensive internal oxidation	104	
1300	6.1	490.6	P	J	H	Slight intergranular corrosion	Extensive internal oxidation	104

1100	30	68.2	R	-1	S	No evidence of oxidation	No evidence of oxidation	104	
1100	27.8	314.5	R	-1/2	S	No corrosion	Some internal pitting	105	
1100	27.8	147.9	R	-1/2	S	No corrosion	No evidence of oxidation	105	
1100	7.2**	950.0	No failure		S	No corrosion	No evidence of oxidation	105

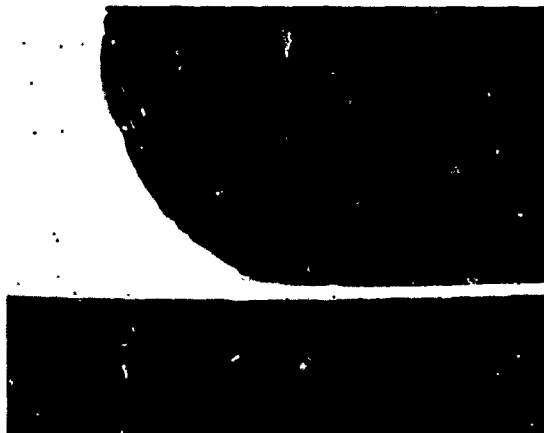
1100°F AND 27.8 KSI, FAILED AFTER 314.5 HOURS

1100°F AND 27.8 KSI, FAILED AFTER 147.9 HOURS

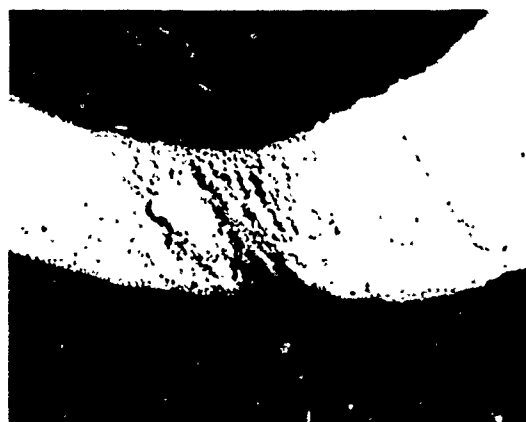
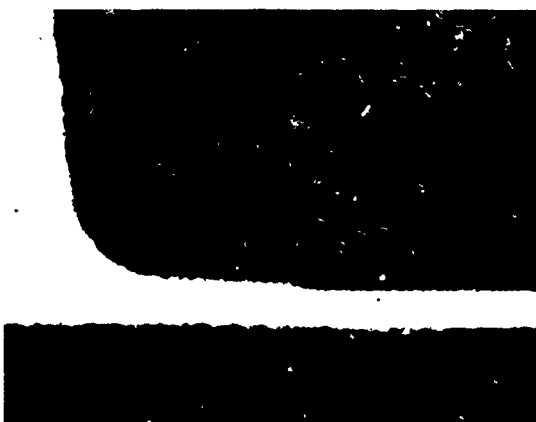
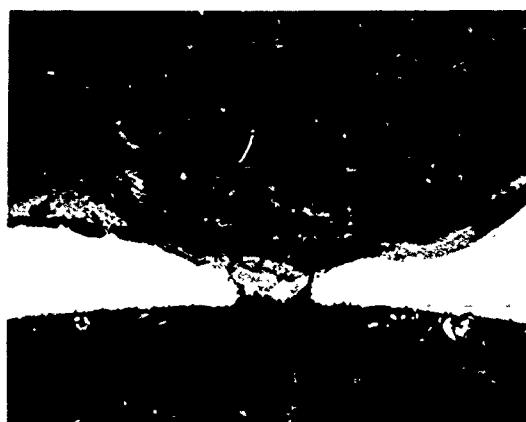
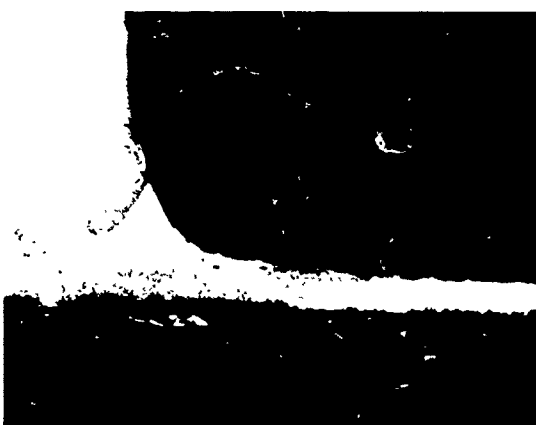
Figure 106. Photomicrographs of Incoloy 800 Tubes Brazed With Coast Metals 50B Brazing Alloy.

1500°F AND 8.3 KSI, FAILED AFTER 29.8 HOURS

1500°F AND 2.8 KSI, FAILED AFTER 21.4 HOURS

1500°F AND 2.8 KSI, FAILED AFTER 222.6 HOURS

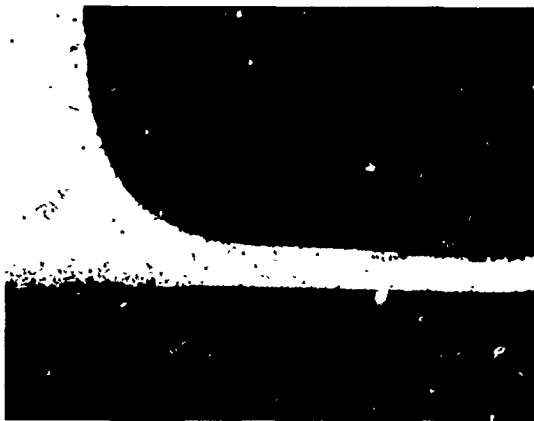
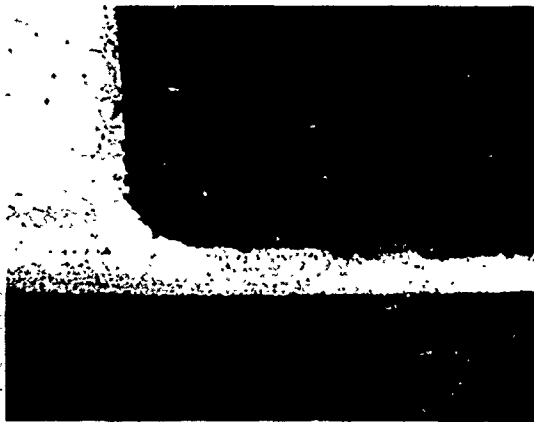
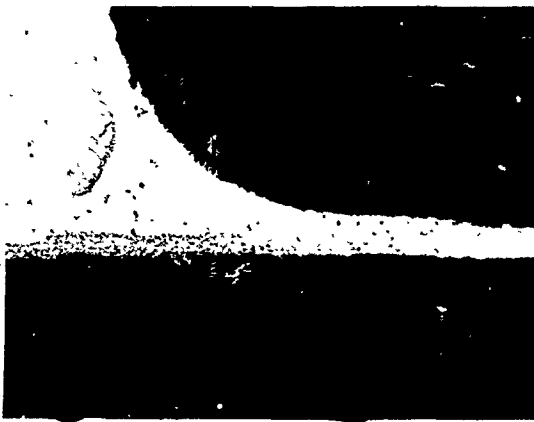
Figure 107. Photomicrographs of Incoloy 800 Tubes Brazed With Coast Metals 50B Brazing Alloy.

1500°F AND 2.8 KSI, FAILED AFTER 502.0 HOURS

1500°F AND 2.8 KSI, FAILED AFTER 812.0 HOURS

1500°F AND 1.73 KSI, FAILED AFTER 346.5 HOURS

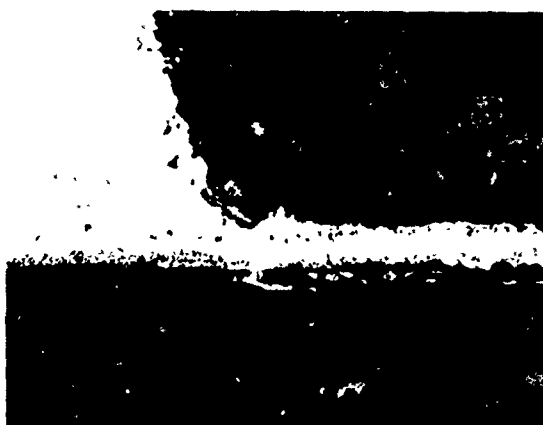
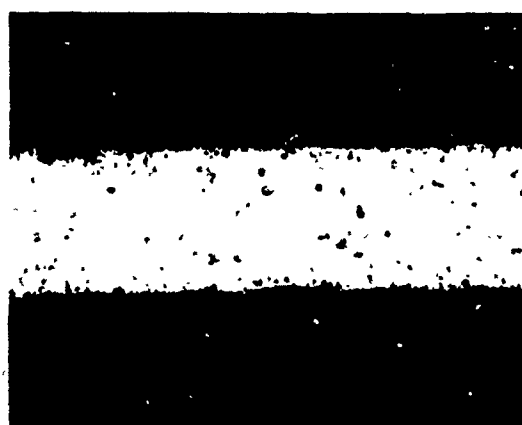
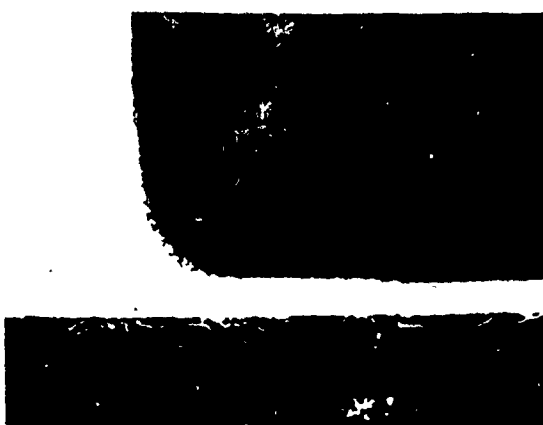
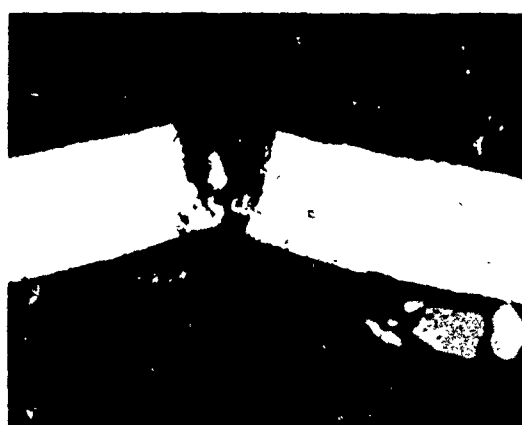
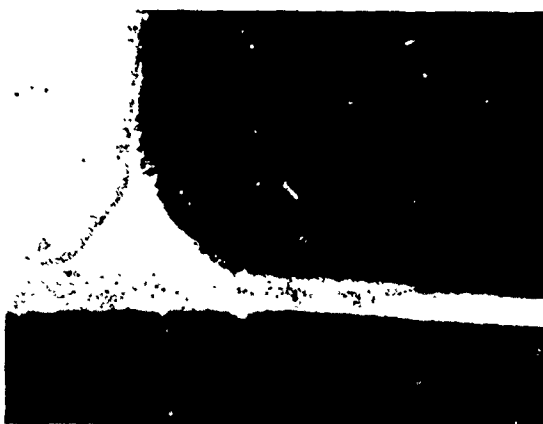
Figure 108. Photomicrographs of Incoloy 800 Tubes Brazed With Coast Metals 50B Brazing Alloy.

1500°F AND 1.73 KSI, AFTER 1172.4 HOURS WITHOUT FAILURE

1300°F AND 15.3 KSI, FAILED AFTER 33.6 HOURS

1300°F AND 9.5 KSI, FAILED AFTER 217.5 HOURS

TABLE XXXI. INCOLOY 800 BRAZED WITH COAST METALS 50B, FAILURE AND CORROSION EXAMINATION									
Temperature. (°F)	Stress (ksi)	Life (hr)	Visual Examination*			Metallographical Examination		Photomicrograph Figure No.	
			Failure		Corrosion	Braze Alloy Fillet	Point of Failure		
			Type	Location					
1500	8.3	29.8	P	+1	S	No corrosion	Oxidized through, porous	106	
1500	2.8	21.4	P	+1	S	No corrosion	Intense localized oxidation	106	
1500	2.8	222.6	P	-3	M	No corrosion	Intense localized oxidation	106	
1500	2.8	502	P	+1/2	M	Slight intergranular penetration	Internal oxidation, porous	107	
1500	2.8	812	P	±1	M	Slight corrosion	Internal oxidation, porous	107	
1500	1.73	346.5	P	J	M	Slight corrosion	Slight internal oxidation	107	
1500	1.73	1177.4	No failure		H	Pitted	Slight internal oxidation	108	
1300	15.3	33.6	P	-1/2	S	Slight corrosion	No general penetration, oxidized fissure	108	
1300	9.5	217.5	R	-1-1/2	M	No corrosion	Slight internal oxidation, porous	108

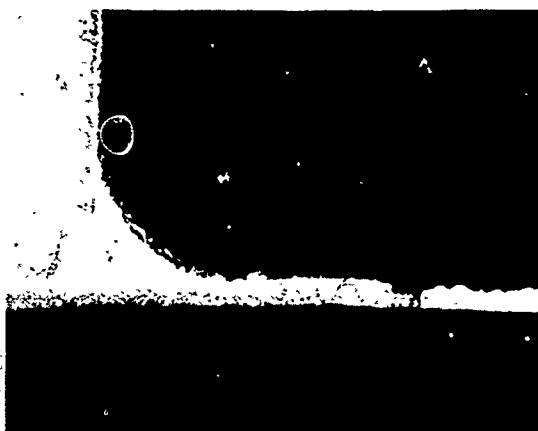
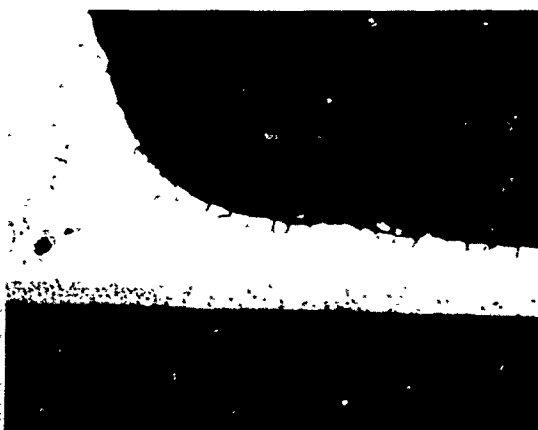
Figure 109. Photomicrographs of Incoloy 800 Tubes Brazed With Coast Metals 50B Brazing Alloy.

1300°F AND 6.1 KSI, FAILED AFTER 1081.5 HOURS

1300°F AND 6.1 KSI, FAILED AFTER 740.1 HOURS

1100°F AND 30 KSI, FAILED AFTER 11.6 HOURS

1300	6.1	1081.5	R	J	M	Slight corrosion	Internal oxidation, porous	109	
1300	6.1	740.1	P	J	M	Slight corrosion	Internal oxidation, porous	109	
1100	30	11.6	P	-3	S	No corrosion	Slight internal oxidation, porous	109	
1100	30	43.4	P	-1 -2	S	No corrosion	Slight internal oxidation, porous	110	
1100	27.8	420.2	P	1-1/2	S	No corrosion	Slight internal oxidation, porous	110	
1100	7.2**	1100	No failure		S	No corrosion	No evidence of oxidation	110

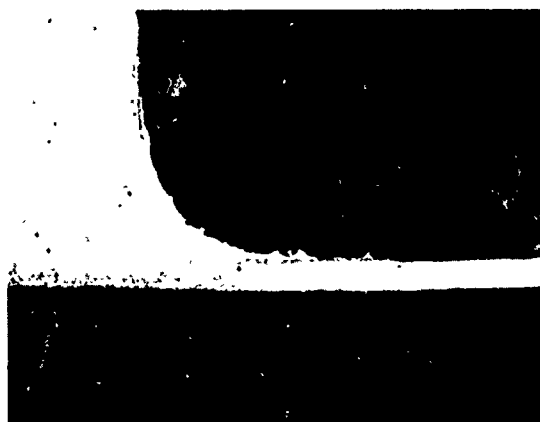
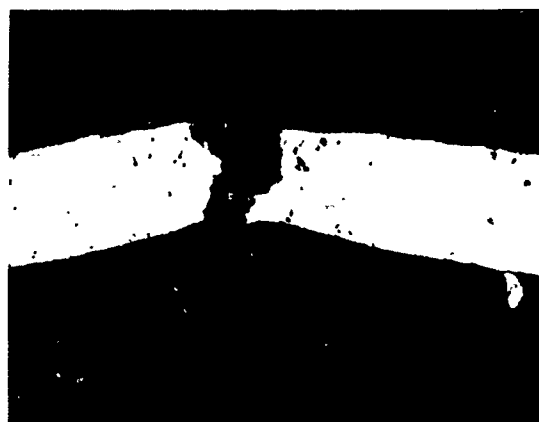
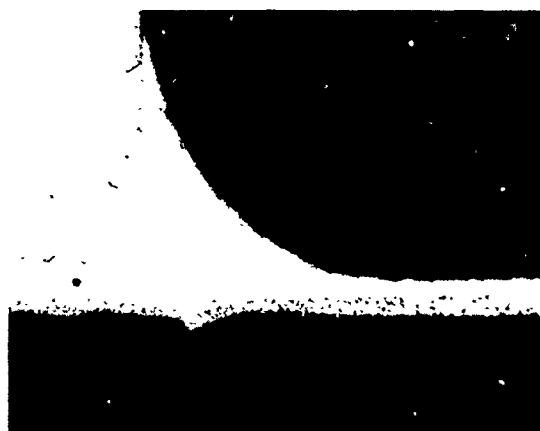
1100°F AND 30 KSI, FAILED AFTER 43.4 HOURS

1100°F AND 27.8 KSI, FAILED AFTER 420.2 HOURS

1100°F AND 7.2 KSI, AFTER 1100.0 HOURS WITHOUT FAILURE

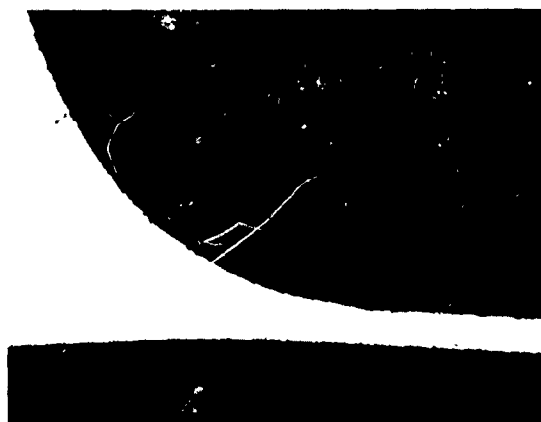
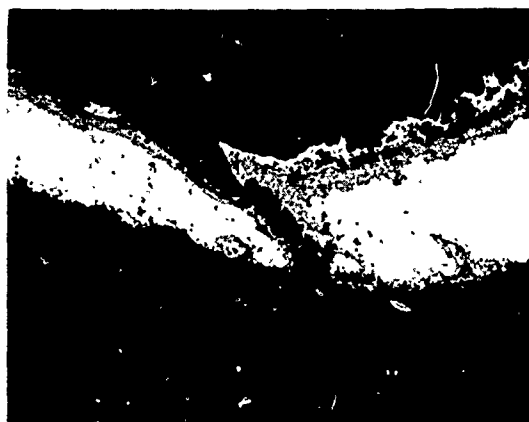
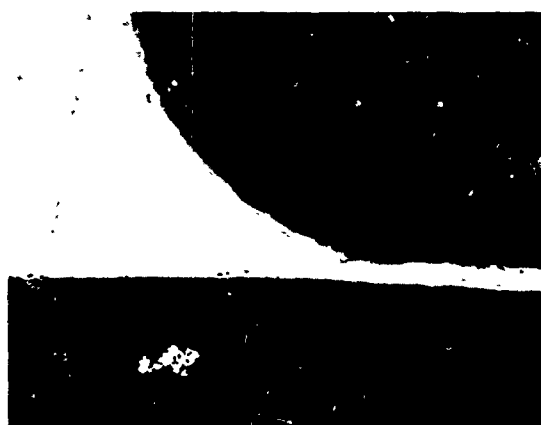
Figure 111. Photomicrographs of Type 347 Stainless Steel Tubes Brazed With Palniro 7 Brazing Alloy.

1500°F AND 9.2 KSI, FAILED AFTER 31.4 HOURS

1500°F AND 9.2 KSI, FAILED AFTER 47.1 HOURS

1500°F AND 5.0 KSI, FAILED AFTER 129.4 HOURS

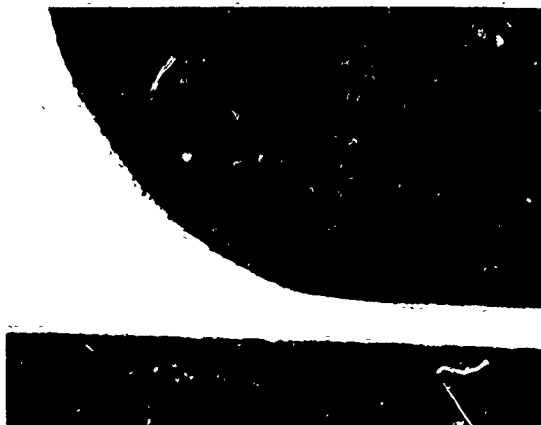
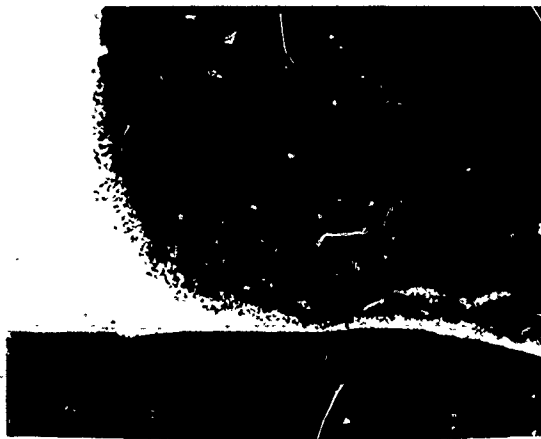
Figure 112. Photomicrographs of Type 347 Stainless Steel Tubes Brazed With Palniro 7 Brazing Alloy.

1500°F AND 3.0 KSI, FAILED AFTER 6.8 HOURS

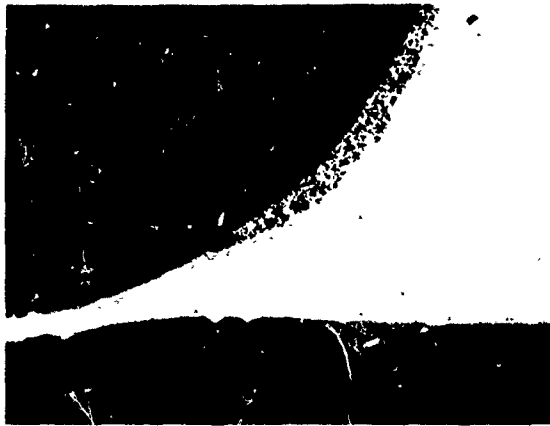
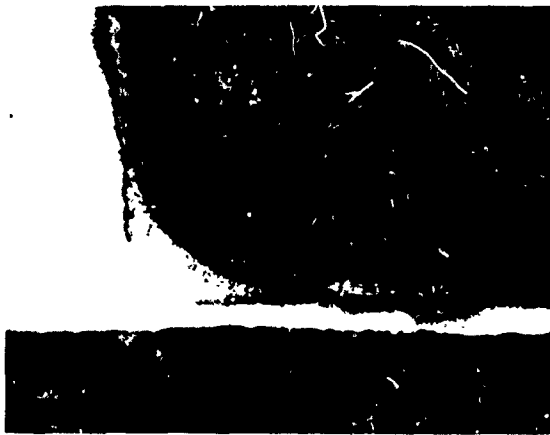
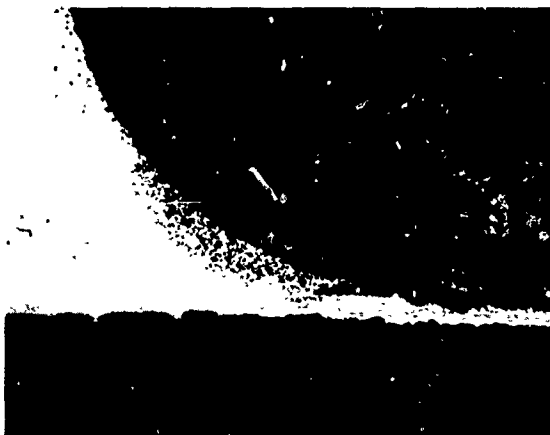
Figure 113. Photomicrographs of Type 347 Stainless Steel Tubes Brazed With Palniro 7 Brazing Alloy.

1300°F AND 10 KSI, FAILED AFTER 608.7 HOURS

1300°F AND 8.0 KSI, FAILED AFTER 486.4 HOURS

1300°F AND 8.0 KSI, FAILED AFTER 465.4 HOURS

TABLE XXXII. TYPE 347 STAINLESS STEEL BRAZED WITH PALNIRO 7, FAILURE AND CORROSION EXAMINATION										
Temperature (°F)	Stress (ksi)	Life (hr)	Visual Examination*			Metallographical Examination		Photomicrograph Figure No.		
			Failure		Corrosion	Braze Alloy Fillet	Point of Failure			
			Type	Location						
1500	9.2	31.4	P	-1	H	No intergranular corrosion	Heavy oxide layer 1-1/2 mils thick, some intergranular oxidation	111		
1500	9.2	47.1	P	-1	H	No corrosion	Slight oxide layer, oxidized fissure	111		
1500	5.0	129.4	P	J	H	Heavy internal oxidation	Heavy oxide layer 2 mils thick	111		
1500	3.0	6.8	R	-1	H	Slight intergranular oxidation	Oxide layer, almost no metal remaining	112		
1500	3.0	154.4	P	J	H	Heavy internal oxidation	Heavy oxide layer 8 mils thick, oxidized all way through tube wall	112		
1300	13.9	104.1	P	+1/2	M	Moderate intergranular oxide layer	Deep intergranular penetration	112		
1300	10.0	608.7	P	J	H	Heavy intergranular oxide layer	Heavy oxide layer 2 mils thick	113

1300	8.0	486.4	P	-1/4	H	Heavy oxide layer, particularly at interface	Heavy oxide layer, metal 1.0 mil thick	113		
1300	8.0	465.4	R	+1	H	Heavy oxide layer, particularly at interface	Heavy oxide layer, metal 0.5 mil thick	113		
1100	35	57.2	R	±1	S	No corrosion	Metal thinning, slight corrosion	114		
1100	30	250.1	P	-2	S	No corrosion	Slight oxide layer	114		
1100	26.9	1238.7	P	+1/4	M	Some intergranular corrosion	Oxide layer 1.0 mil thick	114		
1100	26.9	461	P	J	M	No corrosion	Heavy oxide layer, complete penetration	-		
*P = Pinhole leak; R = Tube rupture; J = Braze joint; + = Above J; - = Below J; S = Slight; M = Moderate; H = Heavy
